# DAMP INVESTIGATION REPORT

| Reference: | <b>SAMPLE</b> |
| Inspection Date: | <b>September 2026</b> |

**Damp & Mould Solutions UK Ltd**

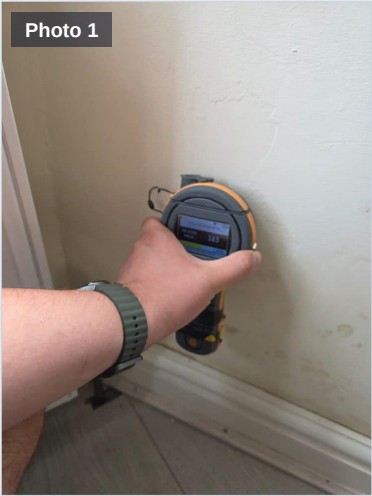
183 REL · DRY

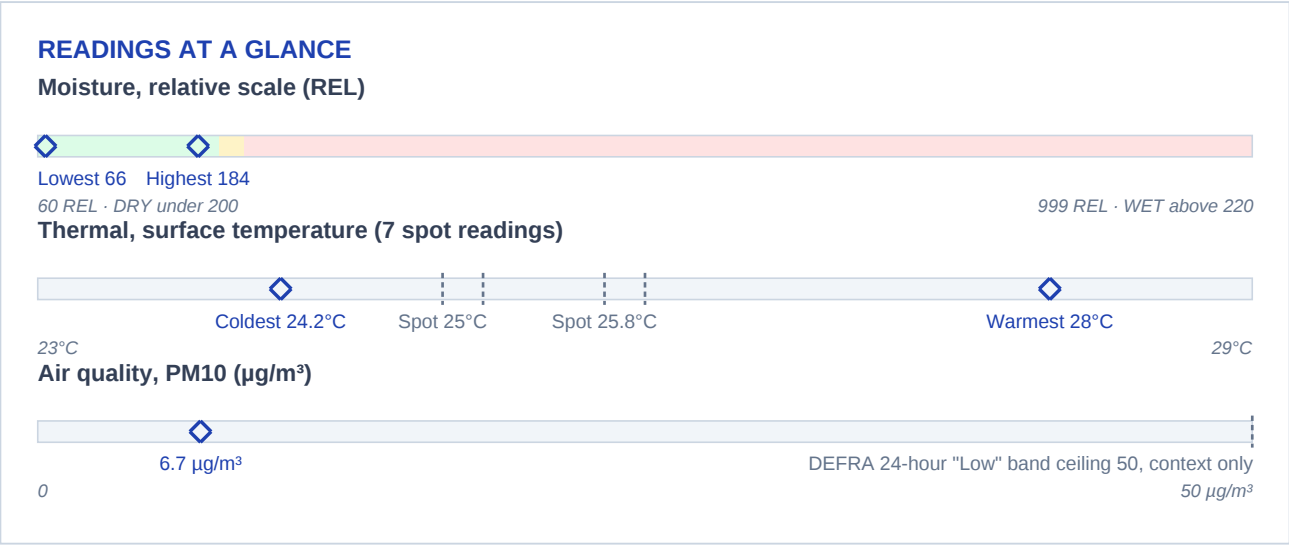
Thermal imaging, surface temperatures

The walls and ceiling were checked with a thermal camera and no concerns were found. Moisture readings were low throughout apart from the corner where the mould is, where readings were slightly high and on the borderline, consistent with condensation on the wall. The mould will need to be treated.

Surface temperatures (thermal), centre spot: 25.2°C, 25°C, 26°C, 25.8°C; difference across the surface 1.6°C to 3.1°C

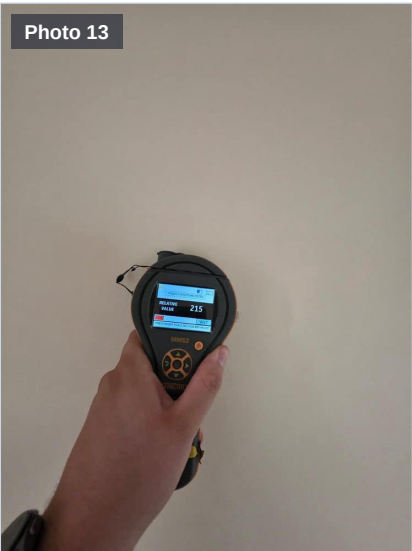
Yellow staining was recorded on the wall in the left-hand corner above the bathroom and on the left-hand side above the stairs. The staining appears to be from an old leak, thought to have come from the roof. These areas were checked with a thermal camera and no evidence of moisture was found, so the leak is not active and has dried out. The remaining landing walls were checked with the moisture meter and showed no sign of dampness.

215 REL · RISK

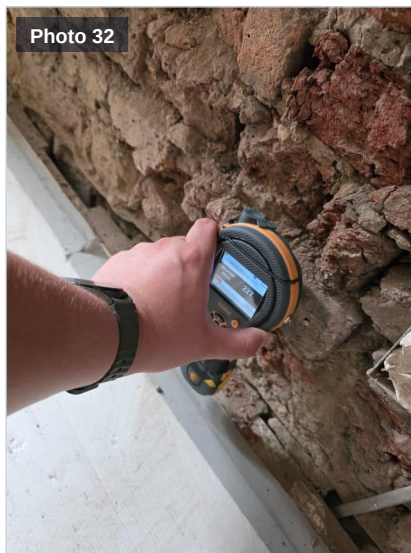
227 REL · WET

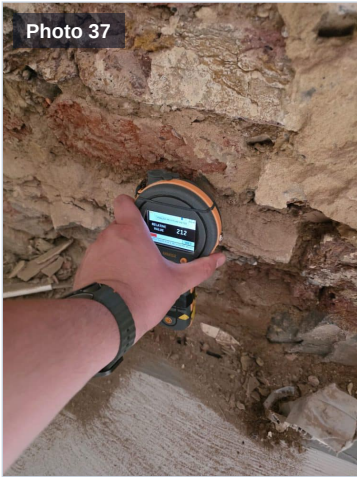
212 REL · RISK

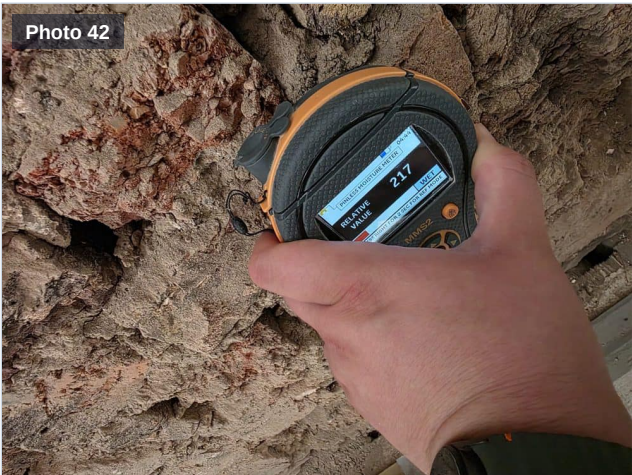
Several external details were identified that could contribute to future damp-related issues. The timber decking has been installed very close to the base of the external walls and sits near the existing low-level air brick, which may restrict effective ventilation and can also hold moisture around the lower wall. The external render extends down to a very low level and may be bridging the damp proof course in some locations. Localised damaged render, previous patch repairs and exposed areas were also noted.

217 REL · RISK

The DPC line should be clearly identified and kept free from render, decking and other external finishes where required. The lower render should be cut back to create a clear separation above the DPC. The existing air bricks should remain unobstructed and subfloor ventilation should be improved. The rainwater pipes and drainage arrangements should also be checked to ensure all joints are watertight and that rainwater discharges effectively away from the building, rather than collecting around the base of the walls.

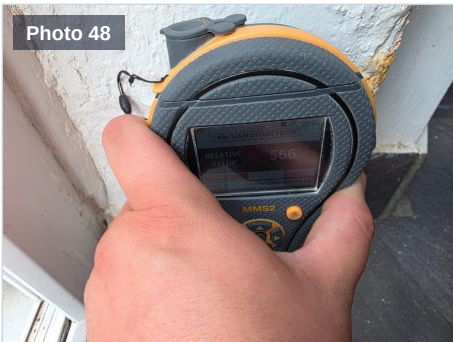
Salt analysis was undertaken on plaster samples collected from two separate walls within the kitchen: the wall on the left-hand side and the wall adjacent to the exit on the right-hand side. Both samples produced positive nitrate results, confirming the presence of nitrate salts within the wall finishes. The fact that these salts were identified at two separate locations, rather than at one isolated point, indicates a wider pattern of salt contamination associated with moisture migration through the masonry.

When these results are considered together with the low-level distribution of elevated moisture readings recorded during the survey, the overall pattern is strongly indicative of rising damp.

566 REL · WET

The affected walls should therefore be treated as suffering from active or recently active rising damp, and remedial works should address both the source of ground moisture and the salt-contaminated plaster rather than relying solely on surface decoration or localised drying.
