# DAMP INVESTIGATION REPORT

| Reference: | <b>SAMPLE</b> |
| Inspection Date: | <b>September 2026</b> |

**Damp & Mould Solutions UK Ltd**

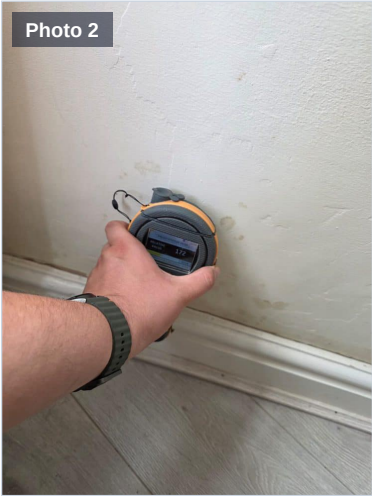
172 REL · DRY

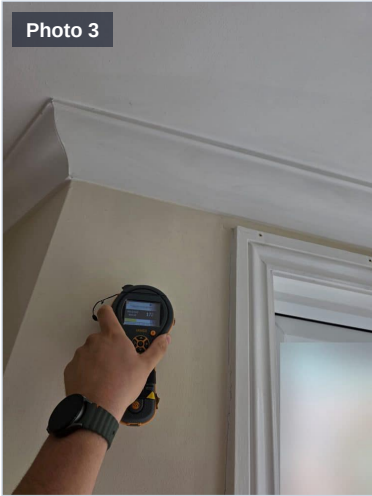
172 REL · DRY

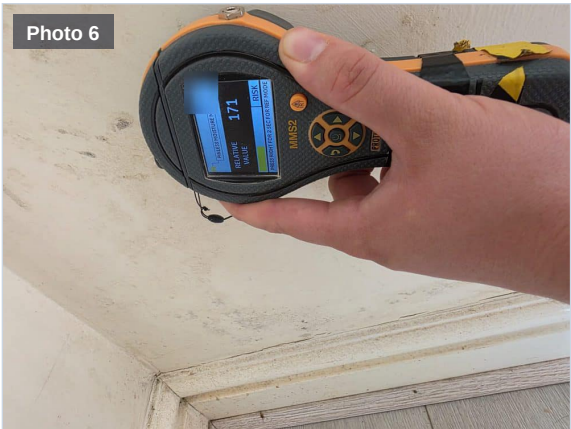
171 REL · DRY

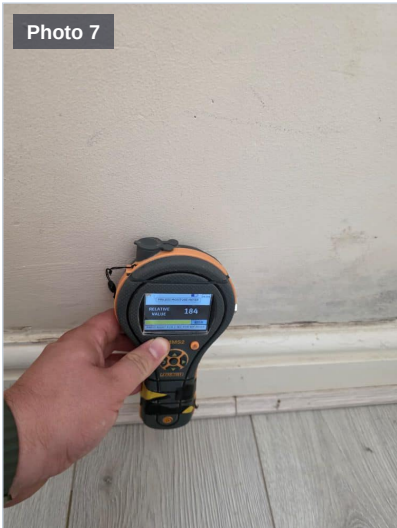
184 REL · DRY

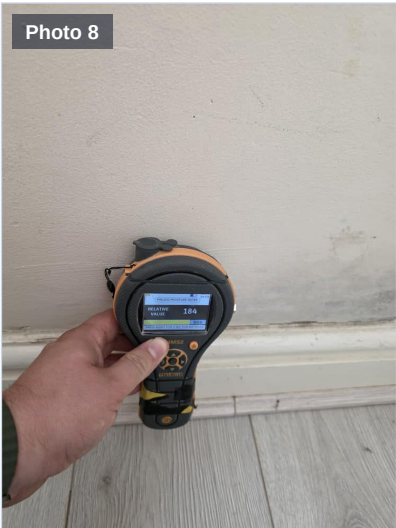
184 REL · DRY

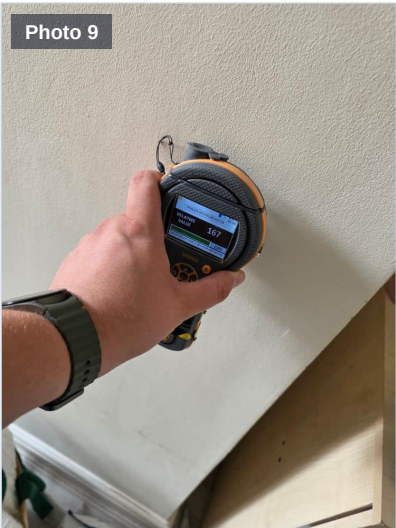
167 REL · DRY

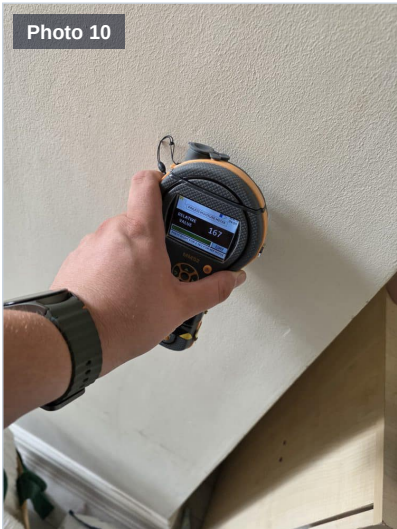
167 REL · DRY

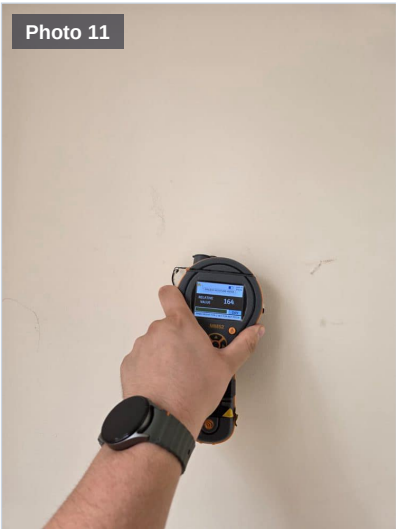
164 REL · DRY

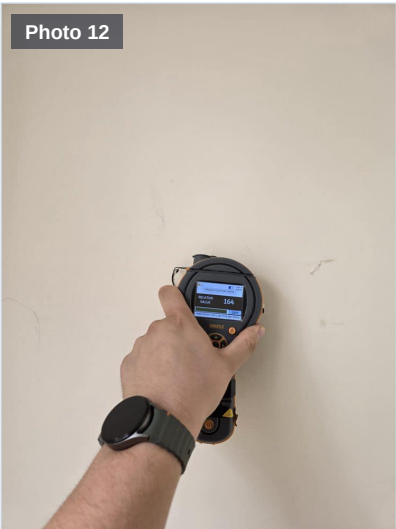
164 REL · DRY

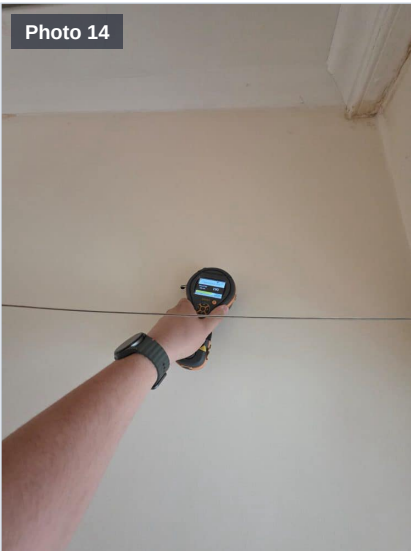
190 REL · DRY

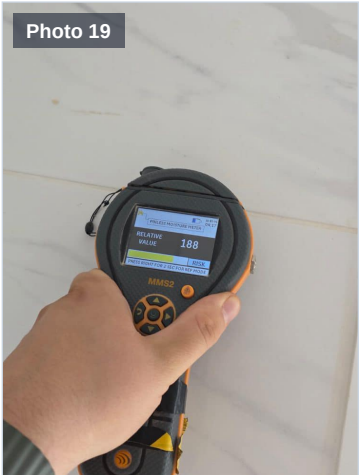
188 REL · DRY

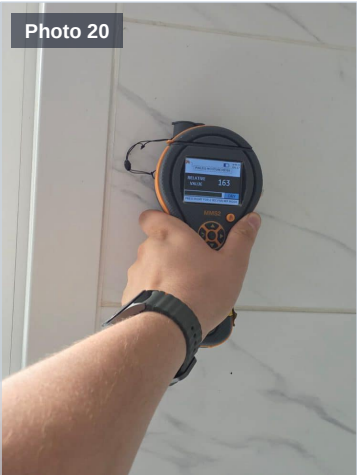
163 REL · DRY

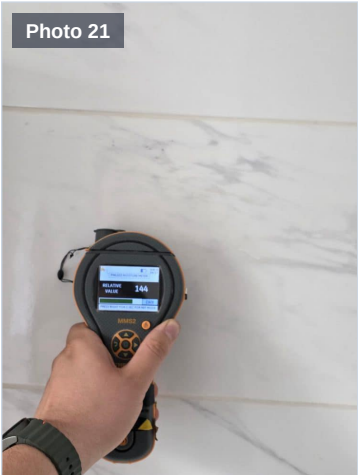
144 REL · DRY

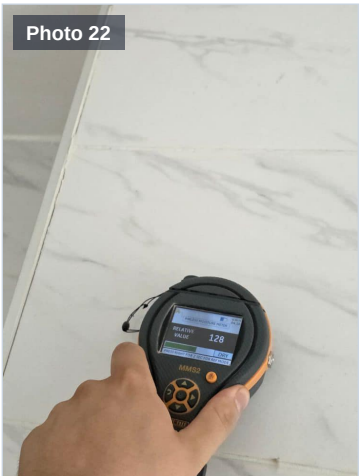
128 REL · DRY

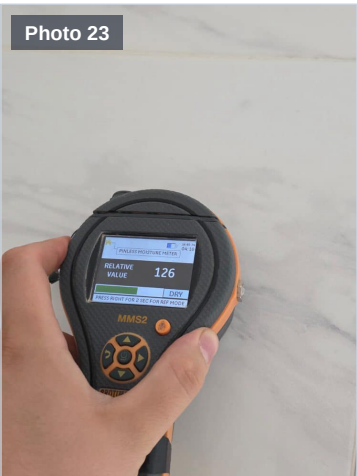
126 REL · DRY

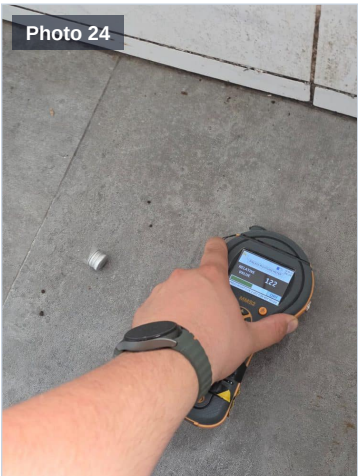
122 REL · DRY

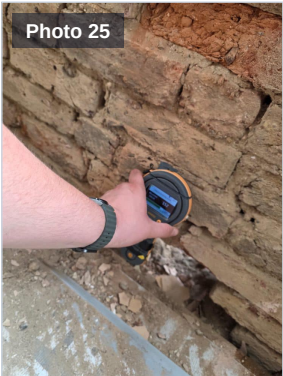
152 REL · DRY

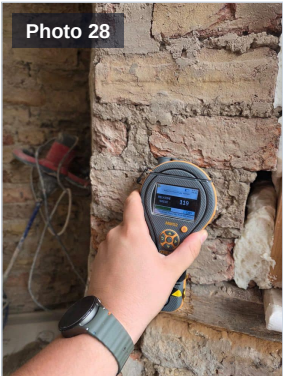
119 REL · DRY

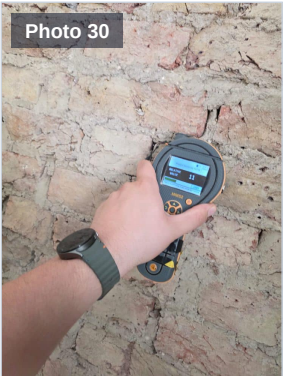
11 REL · DRY

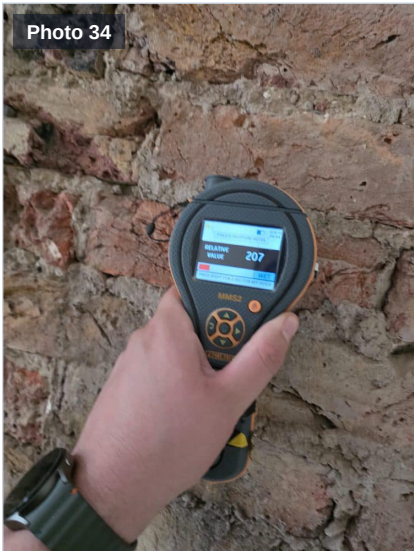
207 REL · RISK

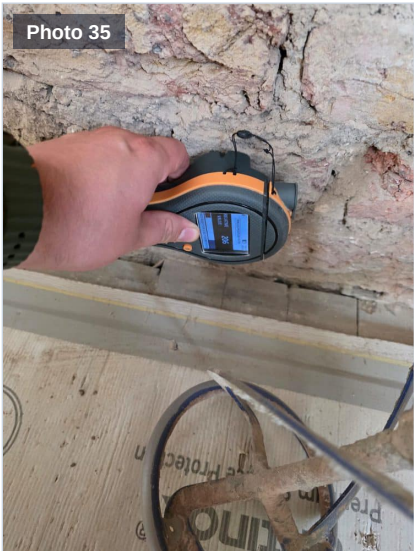
206 REL · RISK

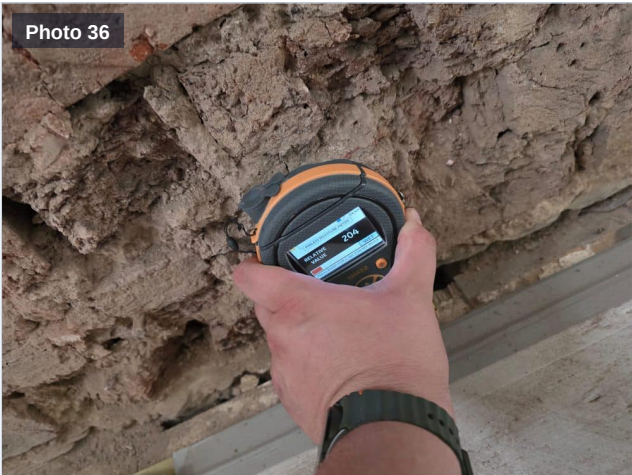
204 REL · RISK

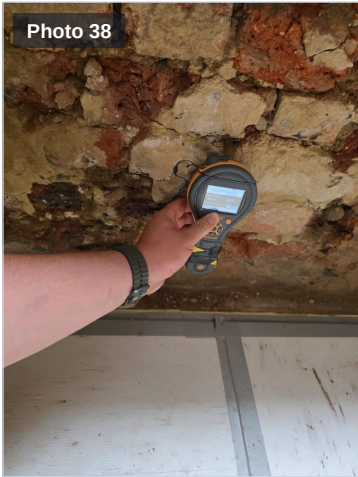
162 REL · DRY

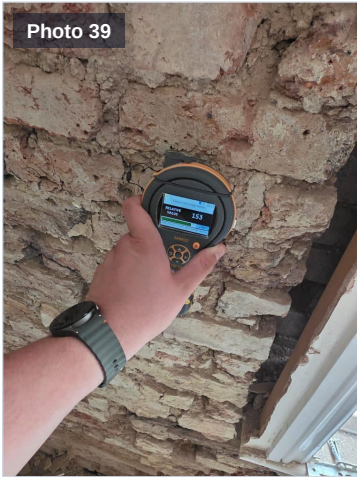
153 REL · DRY

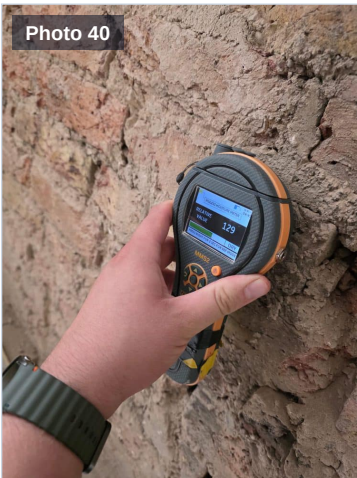
129 REL · DRY

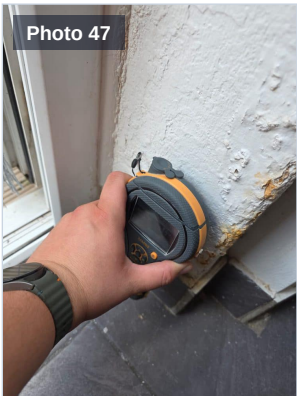
539 REL · WET

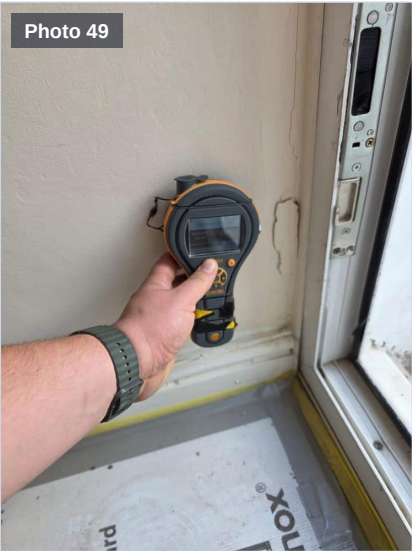
150 REL · DRY

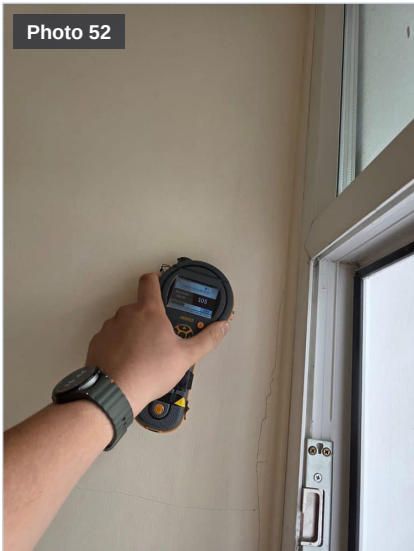
105 REL · DRY

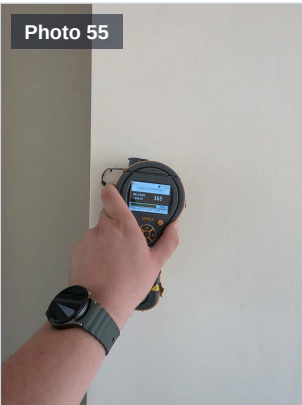
165 REL · DRY

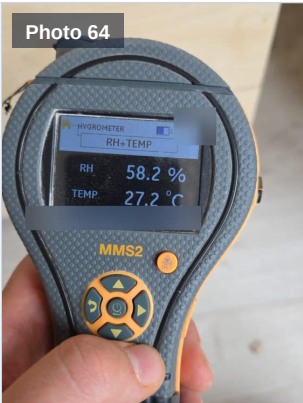
58.2% RH · 27.2°C

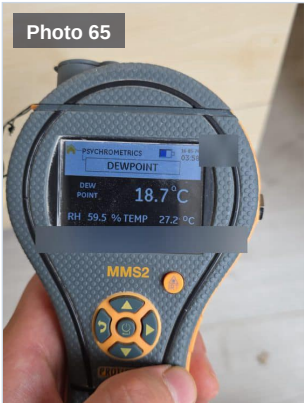
59.5% RH · 27.2°C  
Dew point 18.7°C

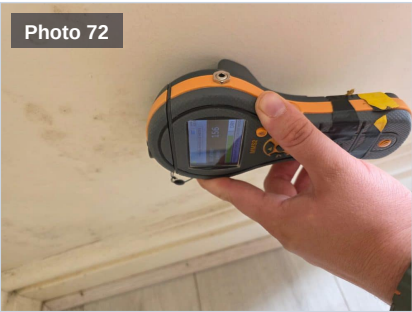
Photo 72

156 REL · DRY

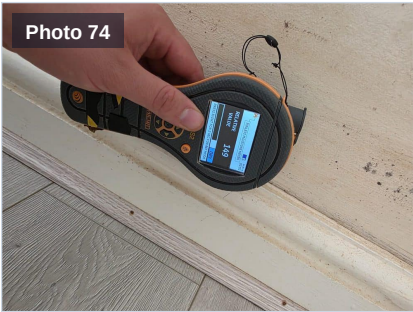
Photo 74

149 REL · DRY

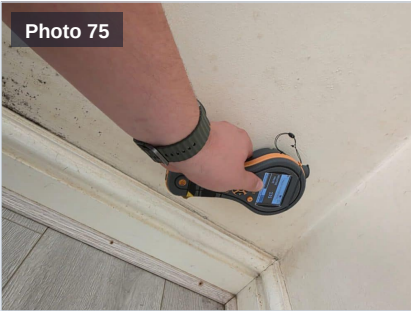
Photo 75

135 REL · DRY

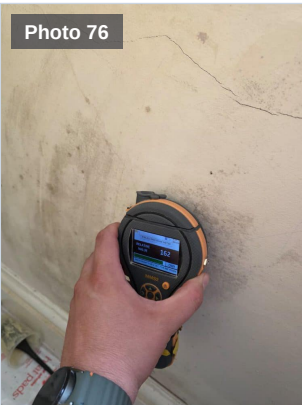
162 REL · DRY

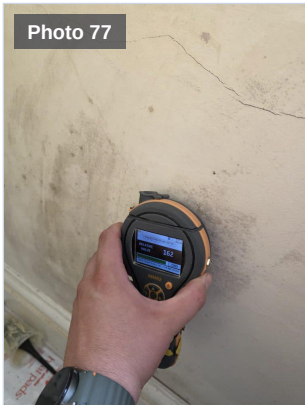
162 REL · DRY

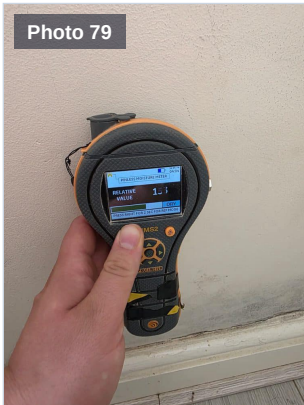
153 REL · DRY

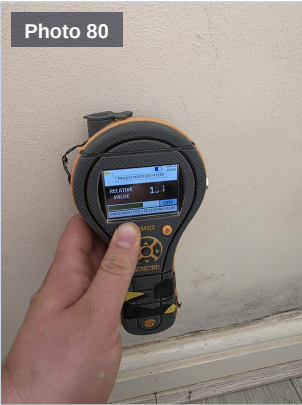
153 REL · DRY

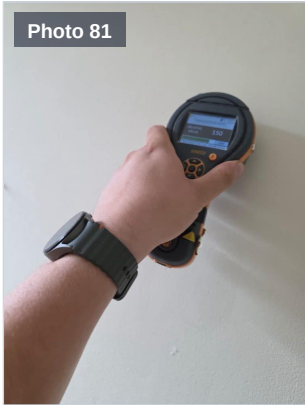
150 REL · DRY

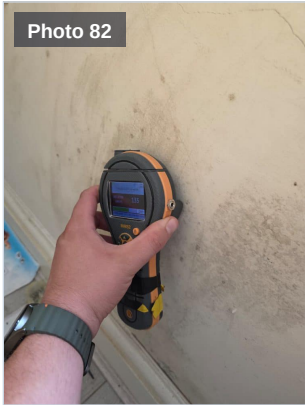
135 REL · DRY

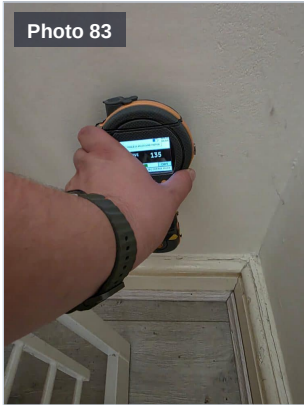
135 REL · DRY

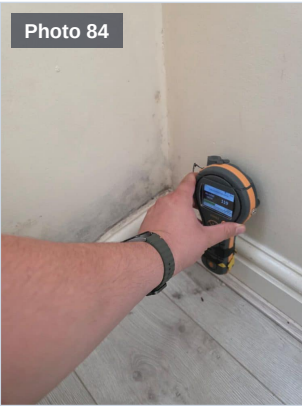
119 REL · DRY

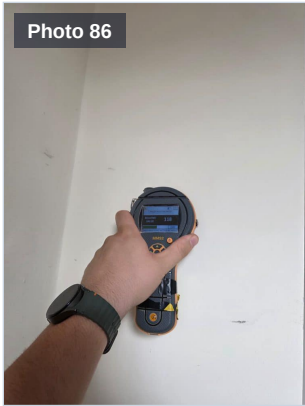
118 REL · DRY

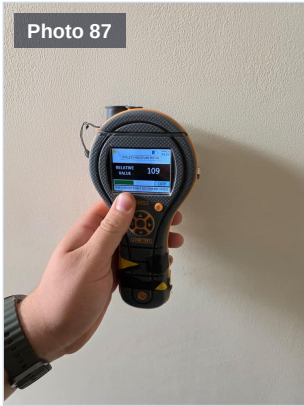
109 REL · DRY

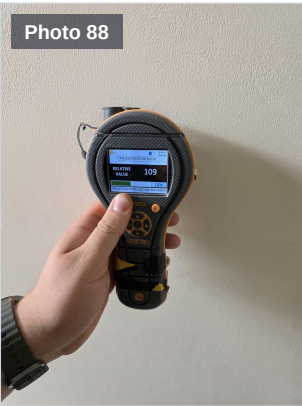
109 REL · DRY

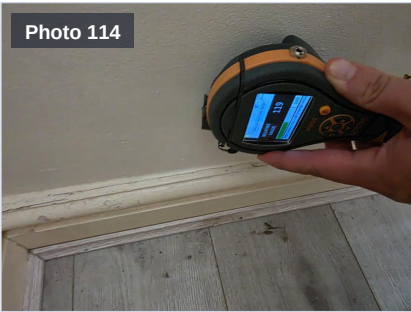
119 REL · DRY

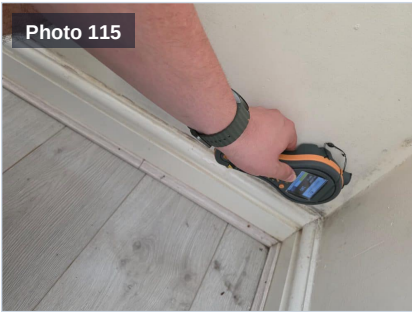
66 REL · DRY · approx.

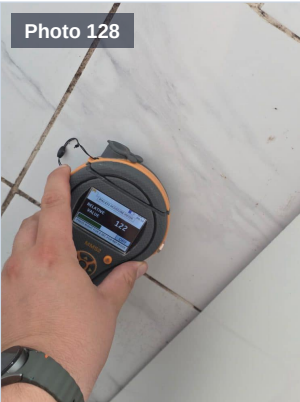
122 REL · DRY

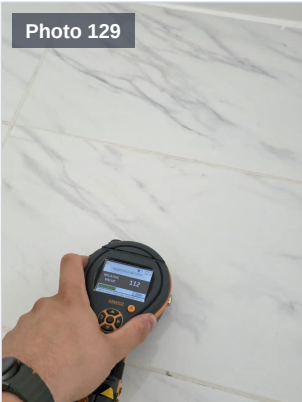
112 REL · DRY

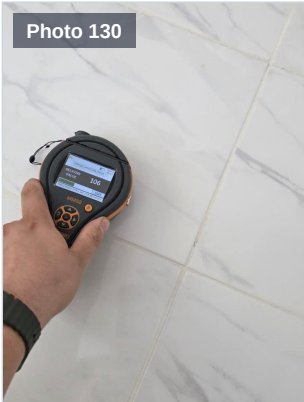
106 REL · DRY

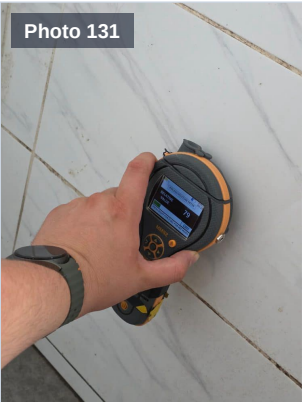
79 REL · DRY

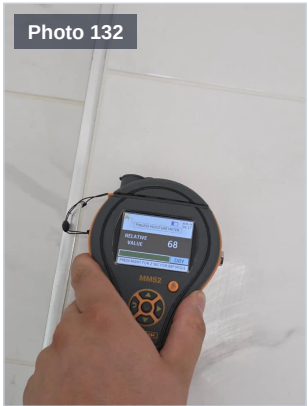
68 REL · DRY

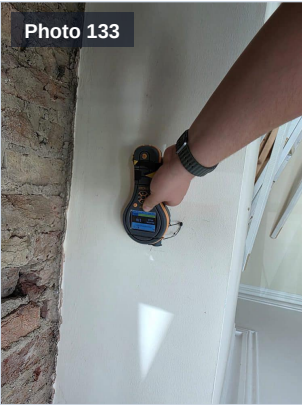
178 REL · DRY

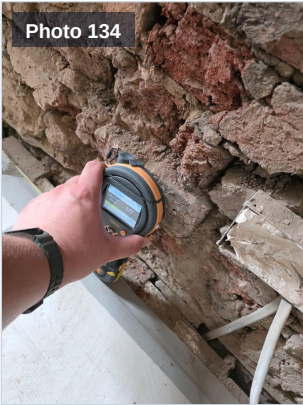
177 REL · DRY

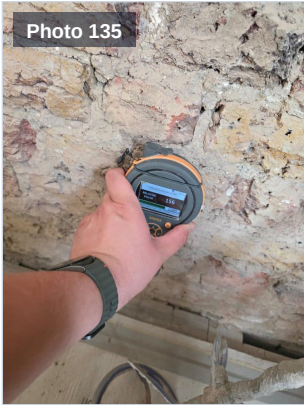
156 REL · DRY

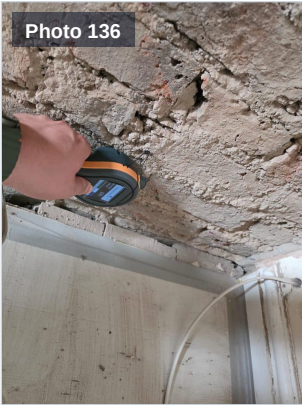
133 REL · DRY

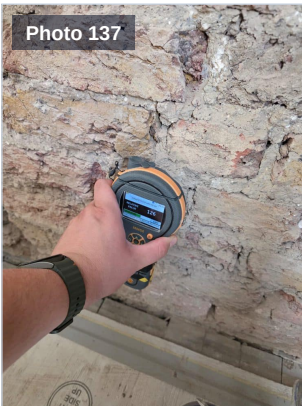
126 REL · DRY

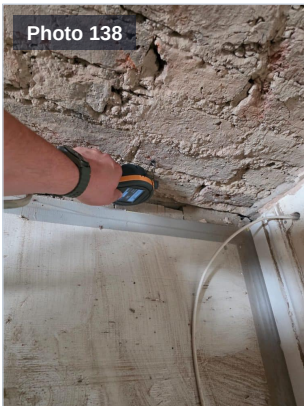
106 REL · DRY

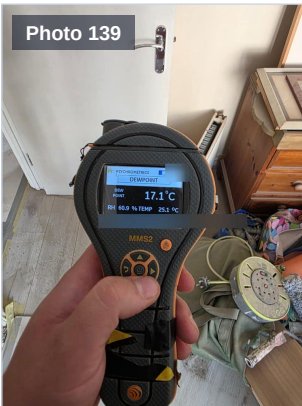
60.9% RH · 25.1°C  
Dew point 17.1°C

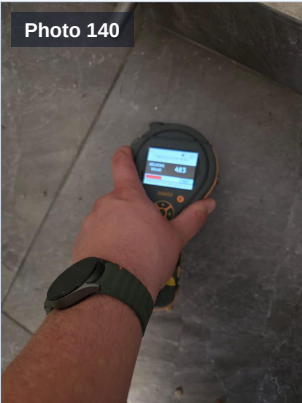
483 REL · WET

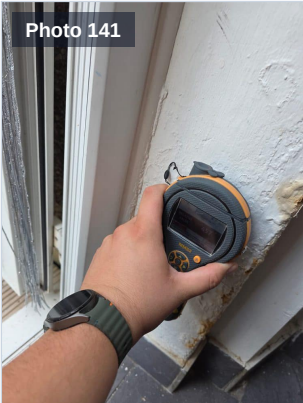
457 REL · WET

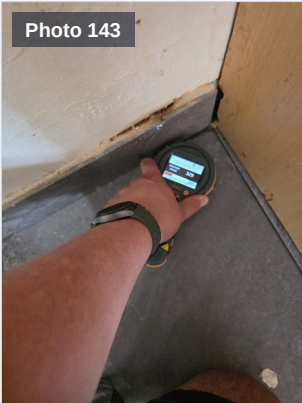
329 REL · WET

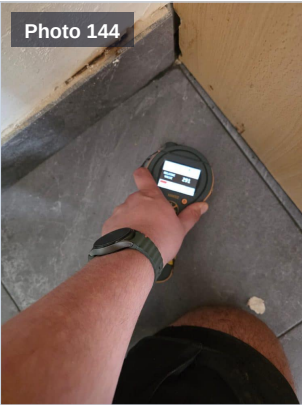
291 REL · WET

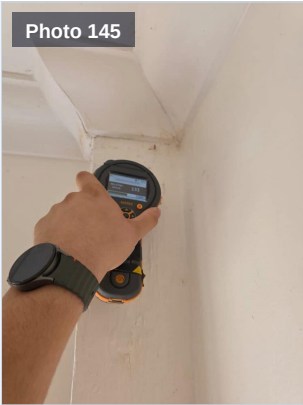
133 REL · DRY

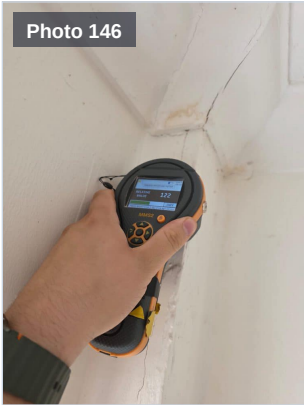
122 REL · DRY

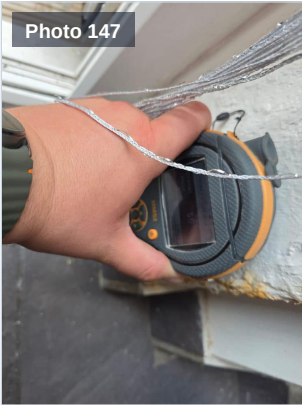
56 REL · DRY

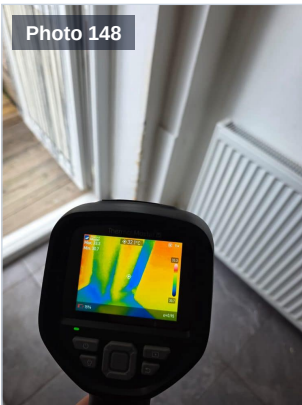
Spot 32.1 · Max 33.3  
Min 30.7°C · e=1

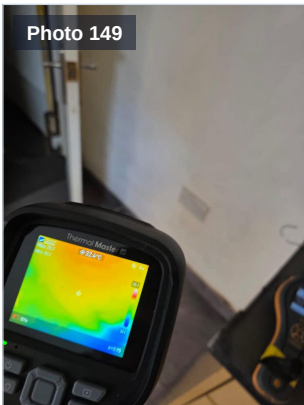
Spot 32.4 · Max 35.7  
Min 31.1°C · e=1

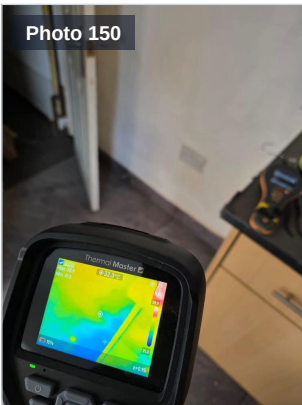
Spot 32.3 · Max 38.9  
Min 31.3°C · e=1
